## CHAPTER 7: SUBWATERSHED RESTORATION STRATEGIES

### 7.1 Brambleton

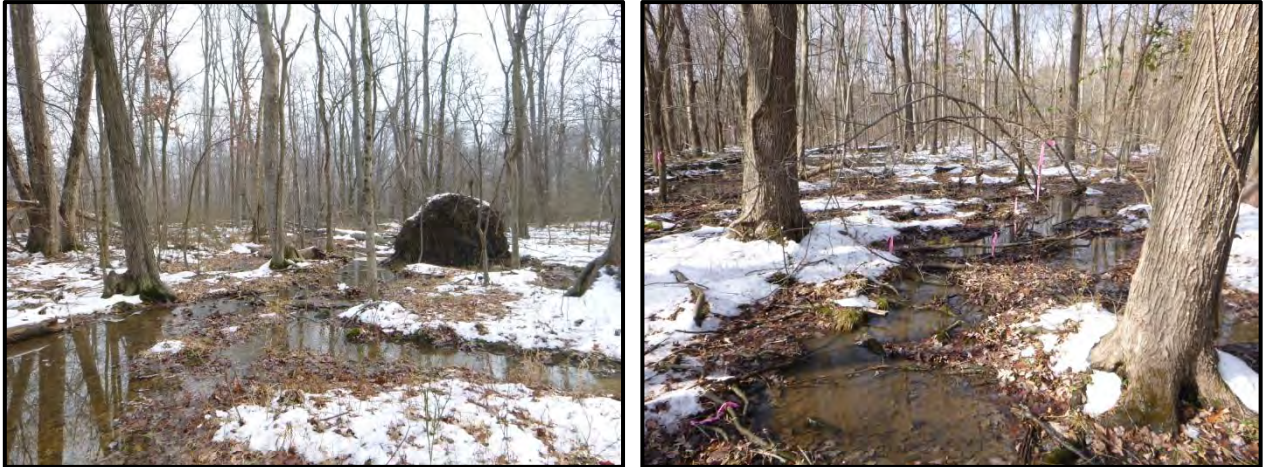
**Figure 7-54: Downstream Section (left) and Upstream Section (right) of Stream Corridor Recommended for Preservation within South Fork Broad Run**

South Fork Broad Run's headwater area was recommended for stream corridor preservation (Figure 7-54). This headwater stream was broken into many small, braided channels connected directly to, or only inches above, the floodplain. Little flow was present here, and almost no bank erosion existed. Most of the upper area possessed broad, forested nontidal wetland buffers; though some recent land clearing activity was encroaching on these buffers in certain areas. The forested buffers possessed moderately large, second-growth deciduous trees, consisting of mainly of pin and white oaks, red maple, and boxelder. Spicebush, cinnamon fern, and Virginia chain fern were the principal species in the shrub and herbaceous layers.

It is important that headwater areas such as these in the Upper Broad Run watershed be preserved wherever possible. Scientific evidence clearly shows that healthy headwaters are inextricably linked to the health of downstream and river ecosystems. Well-buffered, undisturbed headwaters supply organic matter that contributes to the growth and productivity of higher

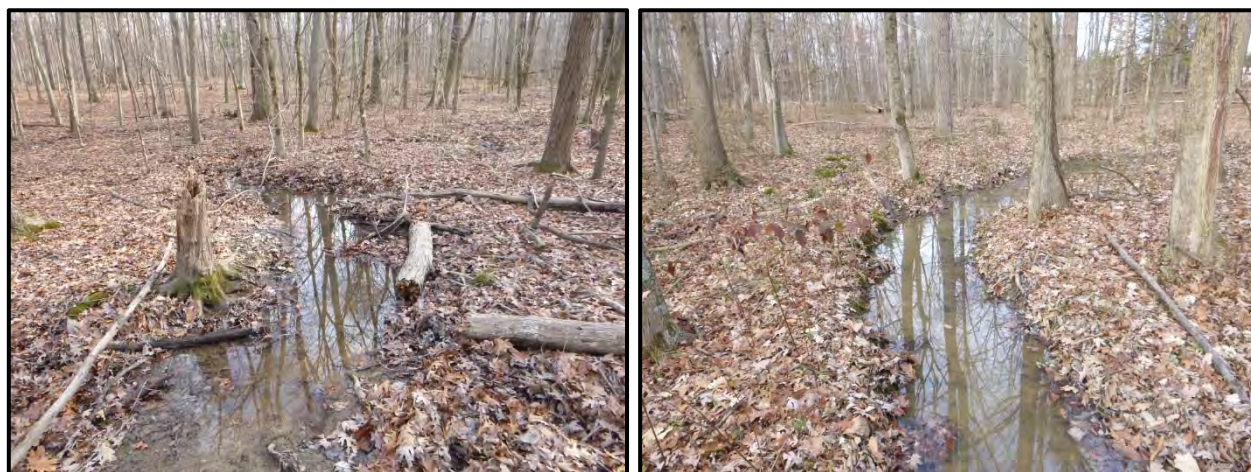
**Figure 7-57: Upper North Fork Broad Run Stream Corridor Recommended for Preservation**

Upper North Fork Broad Run's headwater area was recommended for stream corridor preservation (Figure 7-57). This headwater stream was broken into many small, braided channels connected directly to, or only inches above, the floodplain. Little flow was present here, and almost no bank erosion existed. Most of the upper area possessed broad, forested buffers; some of the forest here was wider than 300 feet on each bank. The forested buffers possessed moderately large, second-growth deciduous trees, consisting of pin, white, and willow oaks, red maple, boxelder, and green ash. The shrub and herbaceous layers were relatively sparse, likely owing to the generally dense tree canopy, but spicebush and sensitive fern were the principal species. Several areas with particularly low topographies along the braided channels comprised forested nontidal wetlands.

It is important that headwater areas such as these in the Upper Broad Run watershed be preserved wherever possible. Scientific evidence clearly shows that healthy headwaters are inextricably linked to the health of downstream and river ecosystems (Meyer et al. 2003). Well-buffered, undisturbed headwaters supply organic matter that contributes to the growth and productivity of higher organisms, including insects and fish. Headwaters also help to keep sediment and pollutants out of the stream system's lower reaches. In addition, they enhance biodiversity by supporting flora and fauna that are uniquely acclimated to this habitat.
